DEPARTMENT OF TRANSPORTATION

Contract #: 04-0120F4Cty: SF/ALA Rte: 80 PM: 13.2/13.9File #: 69.28**WELDING INSPECTION REPORT****Resident Engineer:**Siegenthaler, Peter**Address:** 333 Burma Road**City:** Oakland, CA 94607**Report No:** WIR-021751**Date Inspected:** 14-Mar-2011**Project Name:** SAS Superstructure**OSM Arrival Time:** 700**Prime Contractor:** American Bridge/Fluor Enterprises, a JV**OSM Departure Time:** 1900**Contractor:** Zhenhua Port Machinery Company, Ltd (ZPMC), Changxing Island **Location:** Shanghai,China**CWI Name:** Lv Li Qing /Liu Hua Jie**CWI Present:** Yes No**Inspected CWI report:** Yes No N/A**Rod Oven in Use:** Yes No N/A**Electrode to specification:** Yes No N/A**Weld Procedures Followed:** Yes No N/A**Qualified Welders:** Yes No N/A**Verified Joint Fit-up:** Yes No N/A**Approved Drawings:** Yes No N/A**Approved WPS:** Yes No N/A**Delayed / Cancelled:** Yes No N/A**Bridge No:** 34-0006**Component:** OBG**Summary of Items Observed:**

WELDING INSPECTION REPORT

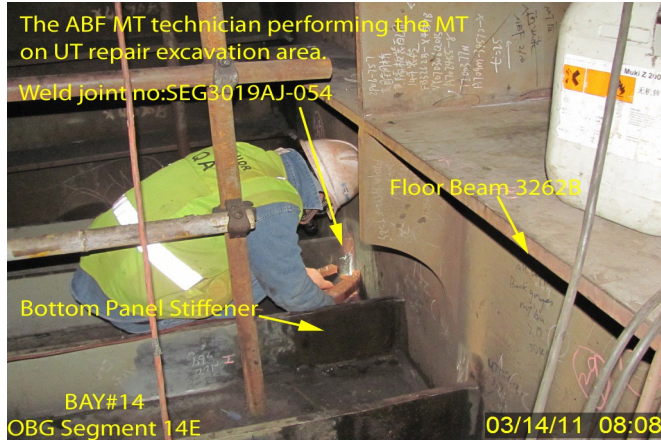
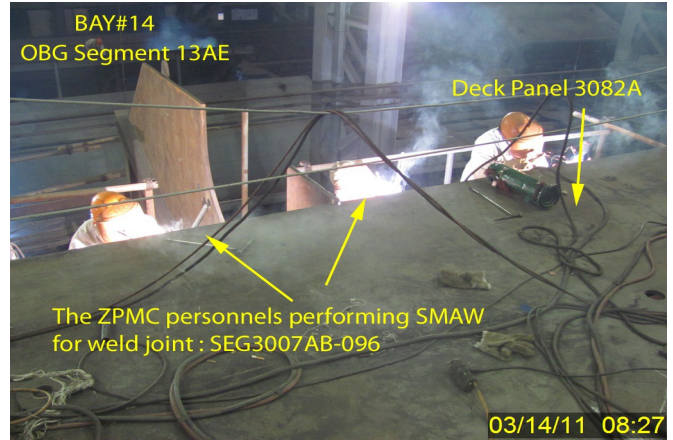
SMAW in the 4G position for the OBG Segment 13AE Deck panel to Edge panel. The weld joint was designated as: SEG3007AB-096. The welders are identified as #068097, 067610 and 037743. ZPMC CWI is identified as Mr. Liu Hua Jie. The welding variables recorded by QC appear to comply with WPS-B-P-2214-TC-U4B-FCM-1. Please see the attached picture.
